Product Case History

Taking the Crunch out of Corrosion – Success at Bick's Pickles

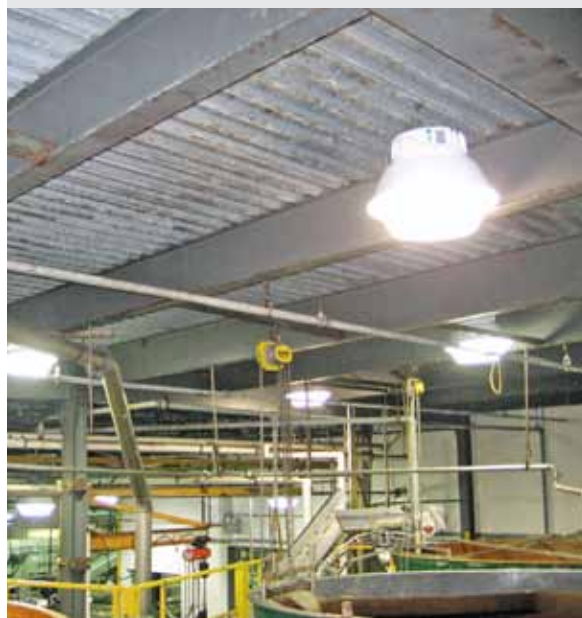
Due to the exposure to high humidity and organic acid vapours, the manufacturing plant had experienced corrosion in their facility. The galvanized ceiling over the production lines, pickle tanks and refrigerators was corroding on the ceiling joints and structural steel beams. The ceiling needed to be repaired within a 12 day time frame and not interfere with the processing areas.

The preparation to repair the ceiling was a commercial blast on the structural steel. A brush off blast cleaning was done on the galvanized ceiling deck where there was no existing iron oxide rust. In heavily rusted areas, spot prime on the galvanized deck was done with Carboguard 890 and then topcoated with Carboguard 890 over an 18,000 square foot area.
