Product Case History

TORONTO, ON

Emergency Medical Services

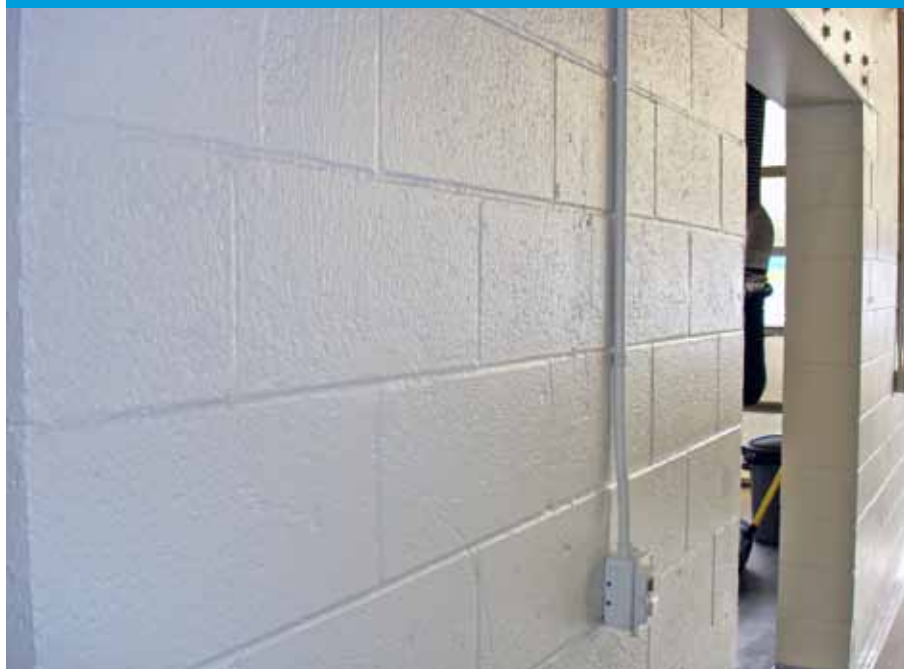
Emergency Medical Services (EMS) Ambulance Station, located in the Toronto area, operates from a thirty year old building. The interior walls of the building have loose, cracked and flaking paint which is caused by the build-up of multiple coats of paint. This causes surface tension with the end result being delamination of the coating.

The Carboline solution was to remove all of the loose and flaking paint by means of a SSPC SP-7 brush off abrasive blast. This method is extremely effective in the removal of the loose paint and exposes the concrete block.

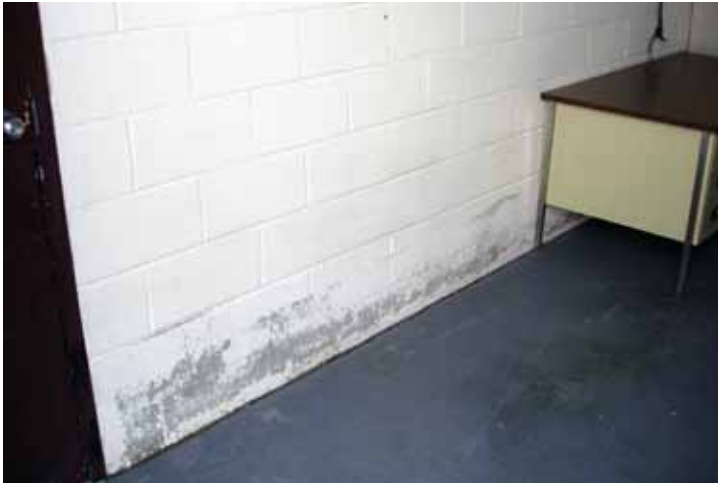
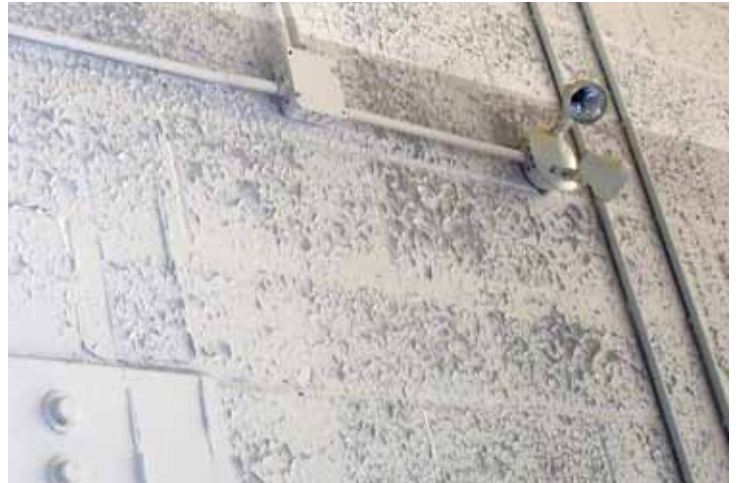
Before Application

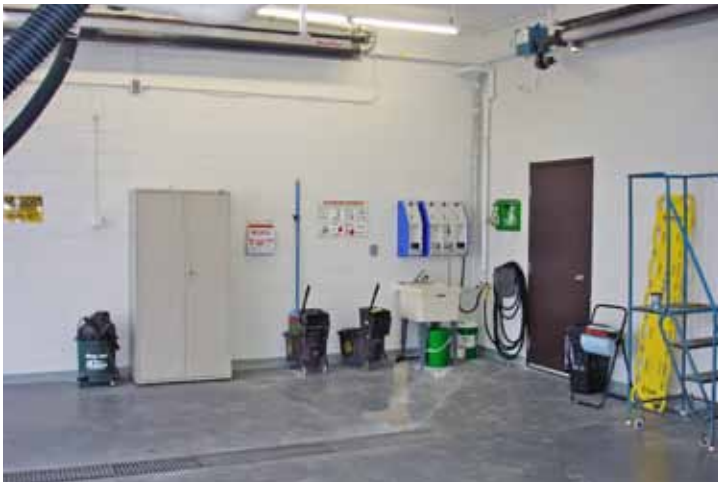
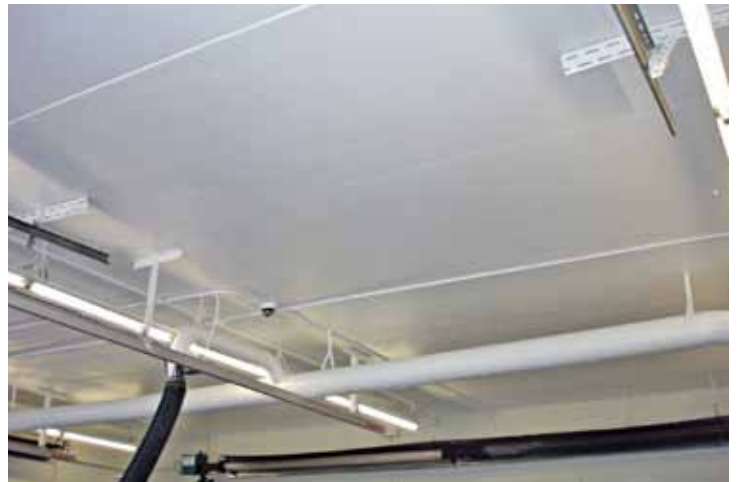
After Application

Carboline's Sanitile 100, a 100% Acrylic Block Filler, was used to seal and "fill in" all exposed concrete block and prime all surfaces that required coating.

Carbocrylic 3359 multi-purpose interior / exterior coating was used for the finishing coat on the walls. Carbocrylic 3359 can be custom tinted to fit any colour scheme and has excellent resistance to water and abrasion.
