Product Case History

Reline of Blended Clay Storage Tank S1-1 - UPM Kymmene Inc.

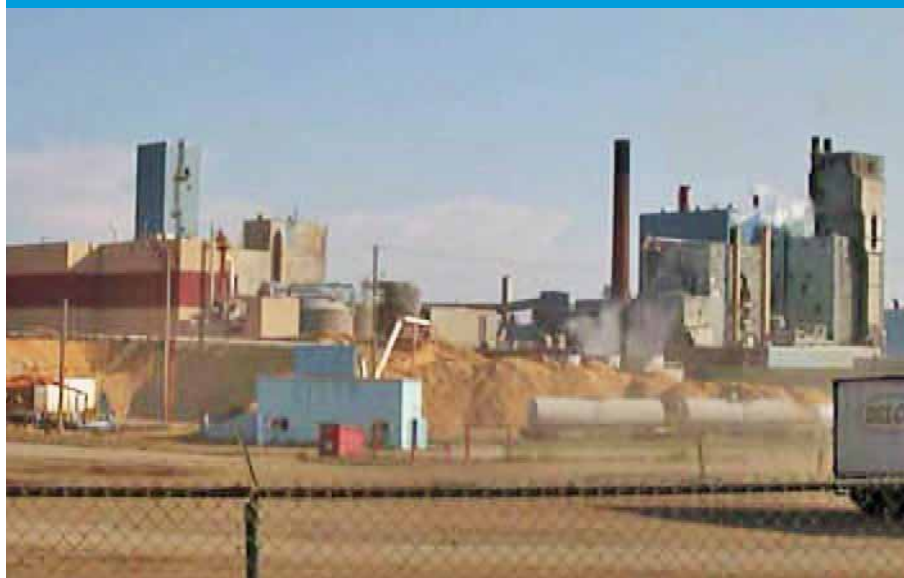
The UPM Kymmene Inc. (formerly Repap) pulp and paper operation routinely performs inspection procedures on their process tanks as a part of their maintenance program. In the course of such inspections, it was determined that Tank S1-1, a steel blended clay storage tank had showed some pitting in the floor that needed repair.

This tank is equipped with an impeller to keep the product fluid, and although the tank had been originally lined in 1989, the perpetual agitation led to a thinning of the lining material. Corrosion had penetrated the liner in pit form causing deterioration in those areas of the tank floor. It was further determined that, although the lining materials had performed beautifully and were still intact on the vertical surfaces, it would be economically prudent to reline the entire structure.

Others repaired the affected floor area and a local Carboline/Plasite approved applicator was contracted to reapply the lining materials inside the tank.

The tank had been originally lined with Plasite Plasguard 7122 HAR (High Abrasion Resistance), a highly cross-linked phenolic with an alkaline curing agent. This material is formulated to provide resistance to a wide range of chemicals. In reviewing the operation of this tank, it was decided that Plasguard 7122 was still the most viable choice of materials for this application. Recognizing the effect of the impeller agitation, Plasite Plasguard 7122 HAR was again selected.

The repaired floor and walls were abrasive blasted to NACE 1/SSPC-SP5 standard for white metal clean with a 3.0 mil anchor profile. Plasguard 7122 HAR was spray applied in two coats at 5.0 to 7.0 mils per coat for a total of 10.0 to 14.0 mils and allowed to cure. Once cured, the tank was returned to service.
