# Product Case History

## St. Lawrence Seaway, Western Region Bridge 19

# St. Lawrence Seaway, Western Region Bridge 19

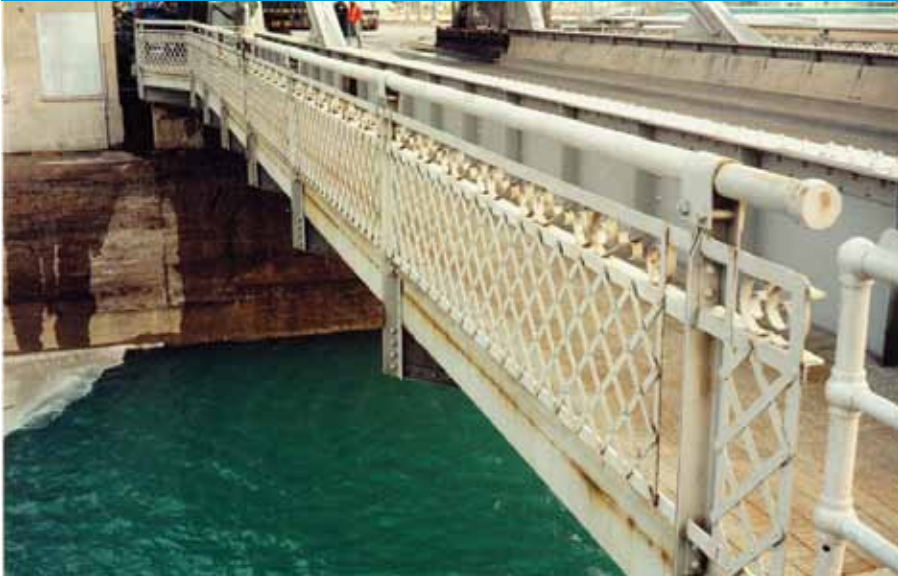
In 1988, the St. Lawrence Seaway Authority, Western Region needed to repaint a badly corroded Bridge 19 over the Welland Canal in Port Colborne.

The repainting of this bridge was difficult due to the fact that it was a hinged counter-weighted bridge that lifted several times an hour to allow shipping to pass. The traffic during the summer shipping season made the sandblasting and painting of the bridge impossible during the summer months. The only time that the bridge could be repainted was during the winter shutdown of the canal, which lasted from January until March.

The system chosen by the Seaway Authority consisted of a 3 mil coat of Carbozinc 11 inorganic zinc, topcoated with one coat of Carboline Carbomastic 242 aluminum filled epoxy urethane at a film build of 5 mils. Both of these products will cure at temperatures as low as -18°C (0°F).

After ten years exposure, a major coatings consultant assessed the condition of the bridge. The assessment was that other than minor staining due to corrosion of back to back members, there was no significant breakdown of the coating system.
