# Product Case History

## Condo Corporation Oakville

Exterior Coating 1: Rustbond  
Exterior Coating 2: Carbothane 134 HG

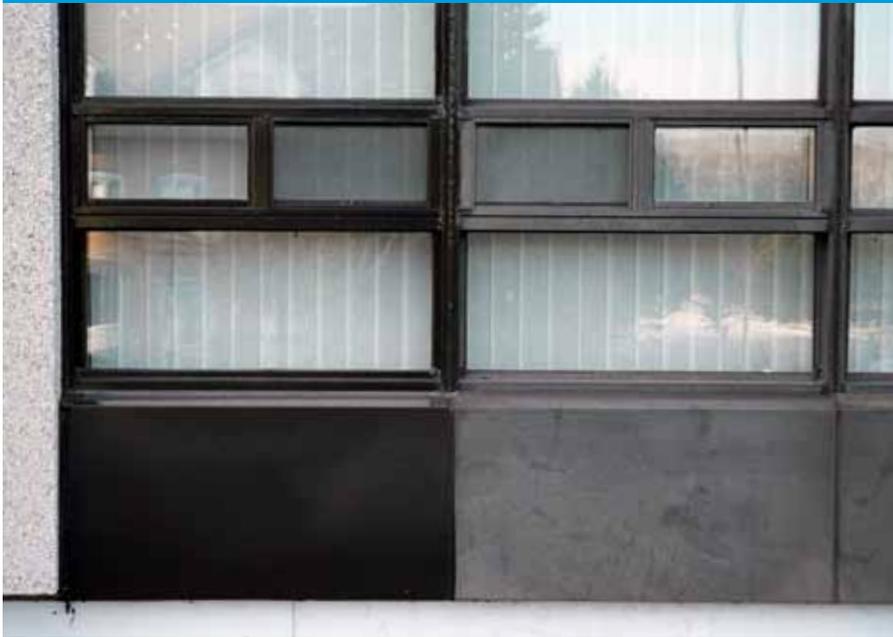
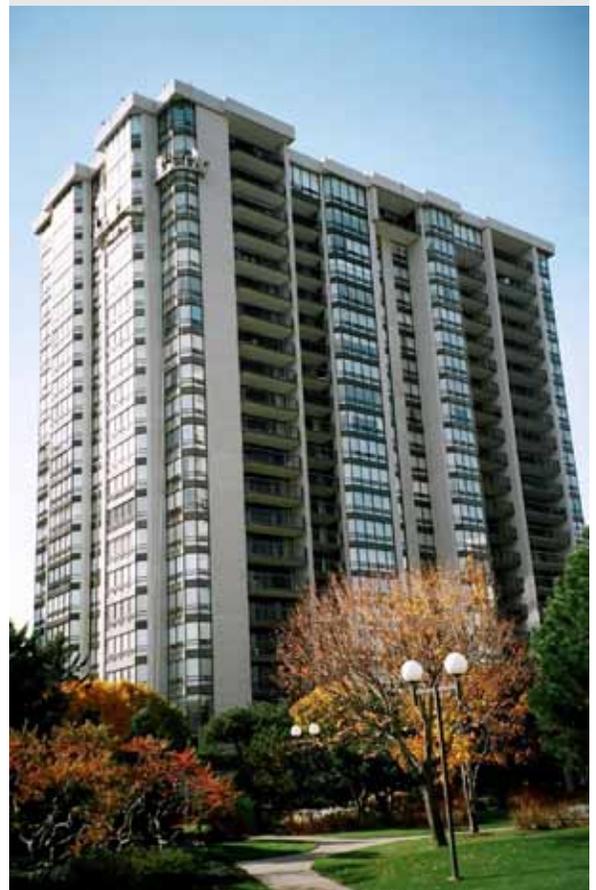
In September 2006, a Condo Corporation decided to restore the exterior of their 24 storey building. The building faced Lake Ontario and was experiencing chalking and fading due to exposure to the elements.

Carboline's Coating System of Rustbond and Carbothane 134 HG eliminated all the customer's existing problems and met the criteria of all parties involved. Rustbond penetrating primer/sealer has excellent wetting properties which allowed the product to penetrate rust and discontinuities in the existing coatings and provide a firm anchorage for a topcoat. The Carbothane 134 HG was chosen for its exceptional weathering performance characteristics. It provided a smooth, durable finish that has superior resistance to corrosion, abrasion and chemical exposure. Together, the two coating system was the perfect solution to the chalking and fading of the building's exterior. Carboline was able to meet and exceed expectations of the Owner, Architect and Contractor.
