# Product Case History

VAL-D'OR, QC

## Quebec Office Restoration Project

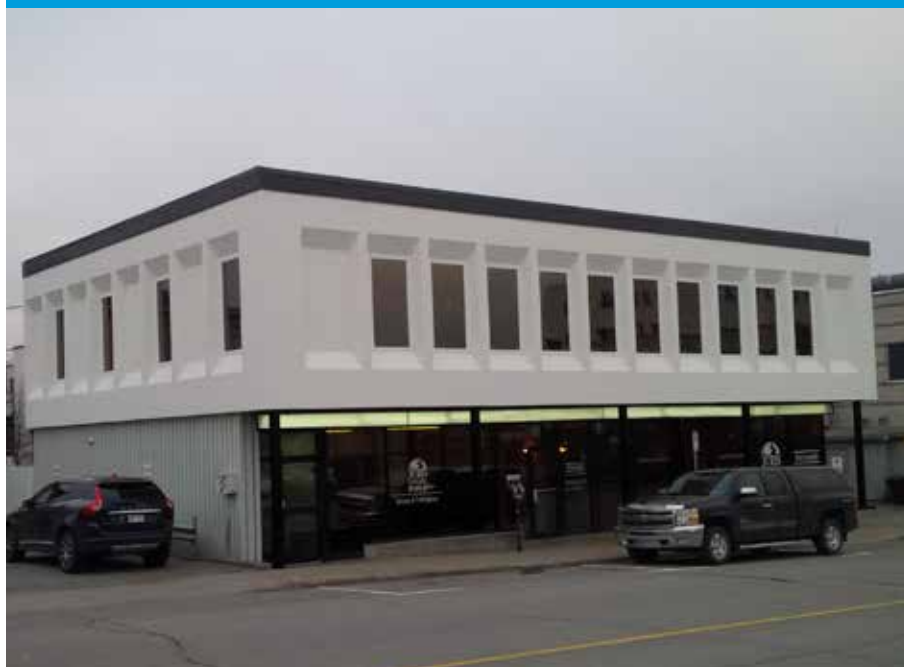
A Quebec office building located on a busy street corner in Val-d'Or had noticed a more than unpleasant sight on its exterior walls. The porous concrete had allowed moisture in causing water stains and unappealing abrasion marks. Not wanting customers to be turned off by the degrading facade, the owners looked to Carboline for a solution. With years of experience in abrasion and corrosion control, Carboline was the best option to complete this job. Carboline was able to provide a much needed facelift that made a substantial improvement to the buildings aesthetics'.

Carboline's solution provided two products used in combination to complete this project. Carbocrylic 120 was chosen as the primer, its ability to persistently adhere to virtually any surface made Carbocrylic 120 an excellent choice to secure the bond. Then the waterborn acrylic Flexxide Elastomer was applied as a finish. Due to its elongation ability and excellent durability this product is more than sufficient at finishing concrete and masonry surfaces.

The arrangement of these products will prevent further water absorption, therefore, preventing additional damage and ultimately, eliminating the unsightly stains, creating a more pleasing store front visual.

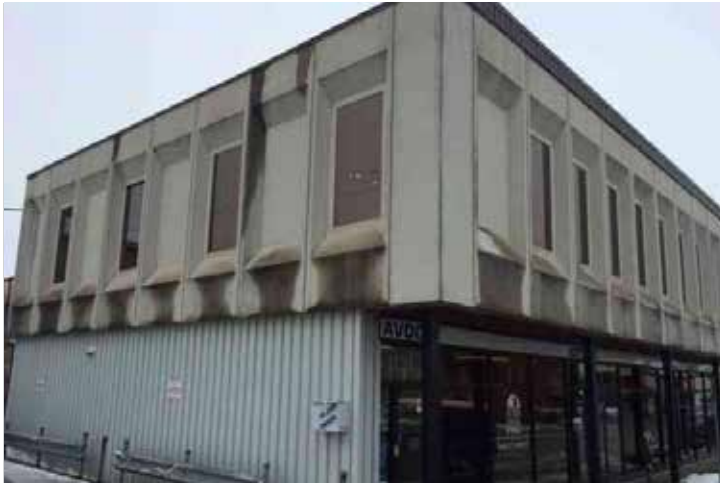
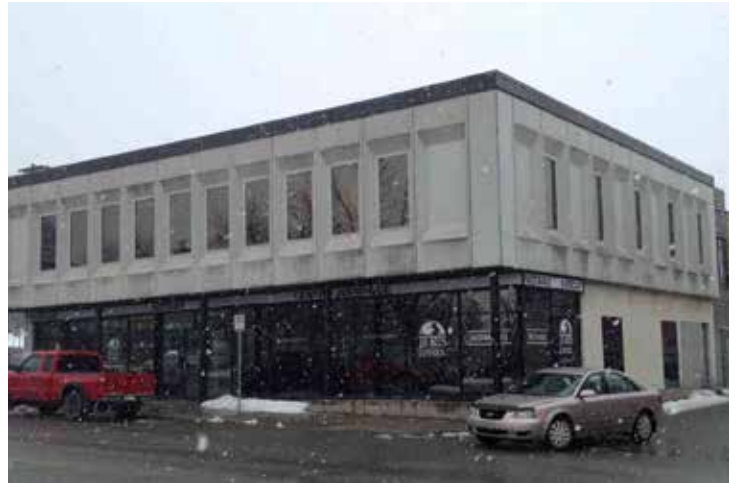
Before Application

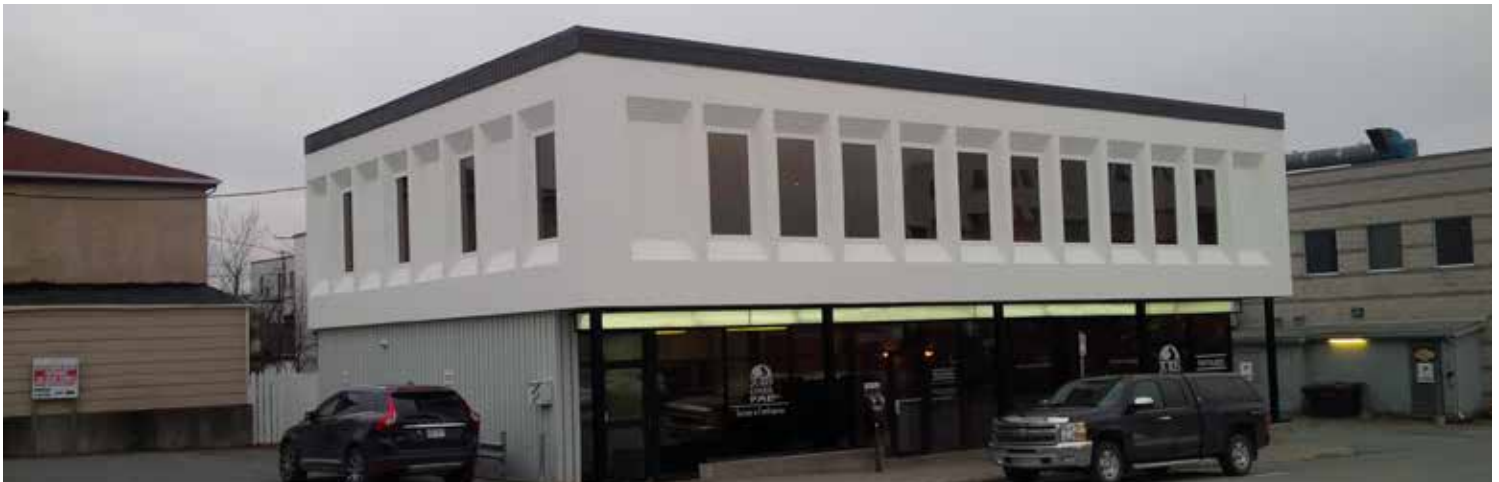
After Application
