Product Case History

Polycon Manufacturers - Automotive Bumper Racks

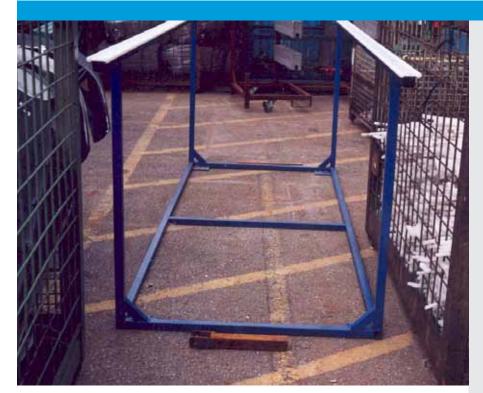
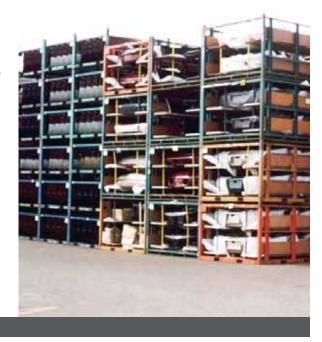
The overall appearance of the product and the total shipping package must reflect quality. Polycon ships the bumpers using their own custom fabrication and painted metal shipping racks. During positioning, loading, unloading, returning and stocking the products, the racks receive a great deal of abuse.

Their in-house paint chipped and multi-coats had to be applied introducing excessive handling of the racks in and out of the spray booths. This process took several days. The low solids conventional paint introduced unacceptable amounts of solvent fumes into the fab shop area, creating unpleasant working conditions. Along with all the undesirables, the paint did not perform to meet the needs of the racks.

The solution is Carboguard 890 cycloaliphatic epoxy. This 77% solids epoxy was applied over a light manual sanding and followed with a solvent wipe. Carboguard 890 was applied in a mist coat or tack coat technique followed by a full coat.

In one shift, the work was completed with virtually no odour. The whole process began at 12pm, ended at 3am with the racks ready for service by 4pm the next afternoon.

Appropriate tests were run on the 890. The "acid test" was conducted by fab shop personnel. A "monkey wrench" was lifted up sixteen feet and then released (dropped) onto a rack coated with 890. The result - no chipping.
