Product Case History

Jembrook Welding

AREA COATED:

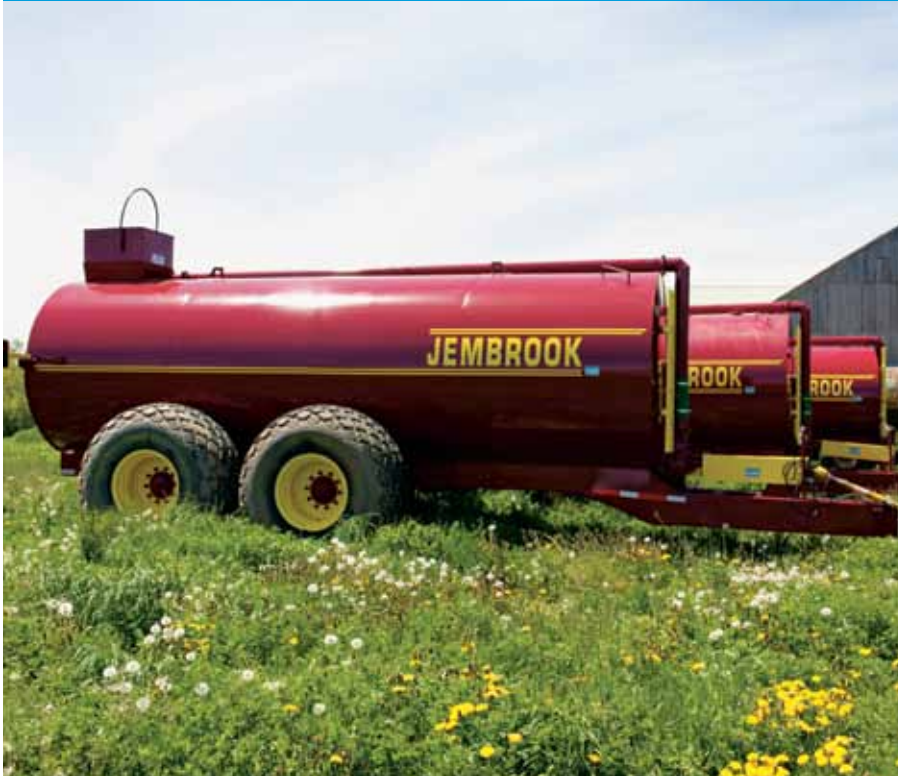
Steel tank wagons are used for transporting and hauling manure. There are a number of factors that contribute to creating an extremely aggressive environment in both the interior and exterior of these tanks, so coatings protection is imperative. Acids found in the manure can degrade the interior steel tank lining, and UV, weather conditions and thermal contraction and expansion of the tank can also magnify the deterioration of the internal and external surfaces.

Phenoline 353 was applied to the interior of the steel tank wagon. This highly cross-linked epoxy lining has extraordinary overall chemical resistance and versatility. It has a unique blend of resins that make it highly resistant to a variety of aggressive cargos. It can be used in both acidic and high temperature caustic exposures.

The exterior of the tank was coated with Carboguard 8922 and Carbothane 8845, in both “Jembrook Red” and “Nuhn Yellow”. Carboguard 8922 is a versatile corrosion resistant coating with surface tolerant properties. Carbothane 8845 is a fast dry, high solids, low VOC, high gloss, high build, two component polyurethane coating. It exhibits outstanding hardness, adhesion and resistance to: impact, marring, abrasion, chemicals and staining.
